# ASPECTS CONCERNING THE RESTORATION OF THE HISTORICAL MONUMENT “ST. NICHOLAS CHURCH” (1594) IN ARONEANU, IAȘI, ROMANIA

## Abstract

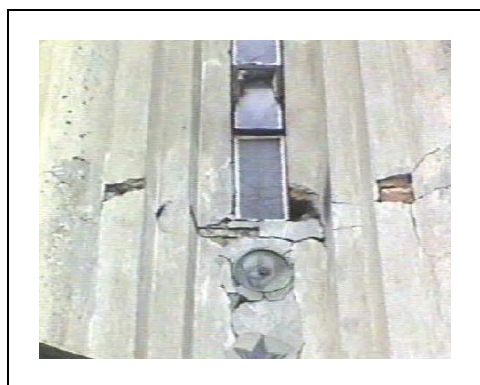
At the time of the intervention, cracks were revealed near the nave windows, on the outside, due to the repeated seismic action suffered by the construction and the uneven settlement of the foundation land [5]. Following the performance of the technical expertise, a series of significant structural degradations were noticed that put the historical monument at risk. Thus, at the level of the nave, cracks were identified in the area of the gaps of the facades, cracks in the apse of the altar and cracks at the cornice, at the tower, diagonal cracks towards the corners of the windows and dislocated and rotated masonry at

the base (Figures 2-3), and at the level of the frame, collapsed, rotten structural beams and leaky casing.

According to the technical expertise, the insurance degree of the nave resulted with the values  $R = 0.28$  in the section from the zero level and  $R = 0.34$  in the section at the base of the windows, about half of the minimum value allowed ( $R_{min} = 0.6$ ). Under these conditions, measures were imposed to strengthen the walls of the nave and the foundations.

**Figure 2.** Structural degradation

In the period 2001-2004, works were carried out to strengthen the spire and the nave, at the level of the roof, which consisted in strengthening the spire by providing 12 reinforced concrete pillars at the edges; on the upper part, the pillars were strengthened with a reinforced concrete belt placed on the crown of the wall; at the base, the pillars were embedded in a belt embedded in the masonry of the stellate base of the tower.

It was also ordered to restore the wooden dome in the form of a brick masonry dome, with a belt at the base, connected by the pillars from the edges of the spire. Later, the star base was strengthened with 6 reinforced concrete pillars, embedded in the masonry. At the upper part the pillars were connected by a belt on a star base and the lower part by a belt on a square base. Also, the consolidation of the square base was carried out with four pillars embedded in the masonry that make the connection between the beams at the base and the belt on the square base.

The execution of four reinforced concrete beams at the base of the tower that ensures the load transfer to the walls of the nave, the consolidation of the semi-dome of the altar with perimeter belts and the creation of a perimeter belt at the level of the cornice of the nave represented vital stages in the consolidation of the historical monument.

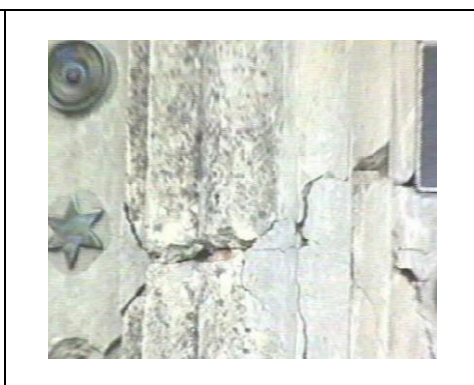
**Figure 3.** Structural degradation

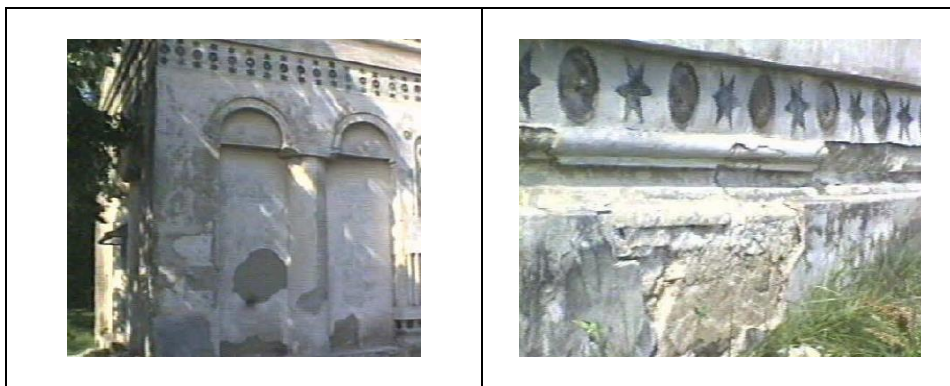
Also, both the general framework and the roof of the spire, in particular, are configured according to the masonry structure over which it rises. In the wet plaster, drawings were executed by folk craftsmen, imitating scribbled models in a clumsy way, however, this is precisely what gives these decorative elements a special charm (Figures 4-5).

**Figure 4.** Facade degradation

**Figure 5.** Socle degradation

As for the finishes, the green and yellow ceramic elements specific to the religious edifice are kept on the outside and a layer of white paint is applied after cleaning the surface of the facades.

The restoration of the original historic exterior appearance was achieved by applying a layer of white paint on cleaned plaster using traditional techniques, thus preserving the monument's original character. Additionally, the green and yellow ceramic elements were enhanced through cleaning, and where necessary, completions were carried out using historical techniques.
