**PROMOTING ORTHODOX IDENTITY THROUGH
ART IN THE CONTEXT OF EUROPEAN
MULTICULTURALISM – RESTORATION OF
THE WOODEN CHURCH DEDICATED TO
“SAINTS ARCHANGELS MICHAEL AND GABRIEL”
BUZEȘTI VILLAGE, FĂRCAȘA COMMUNE,
MARAMUREȘ COUNTY**

Adriana-Gabriela Mardale and Alexandrina Bădescu*

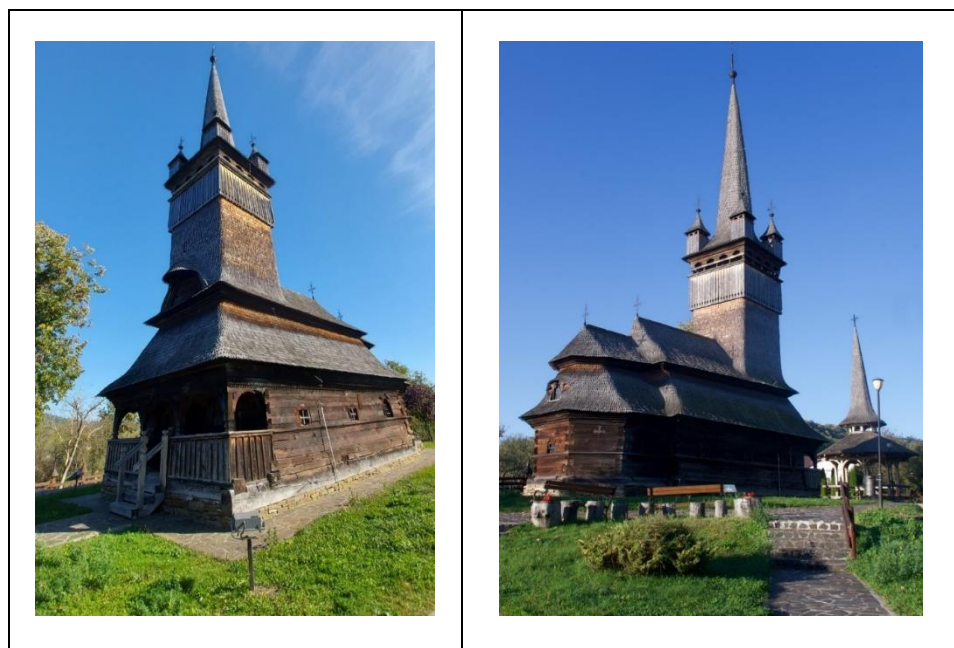
Figure 1. Church assembly – view of the South-West side

Figure 2. Church assembly – view of the North-East side

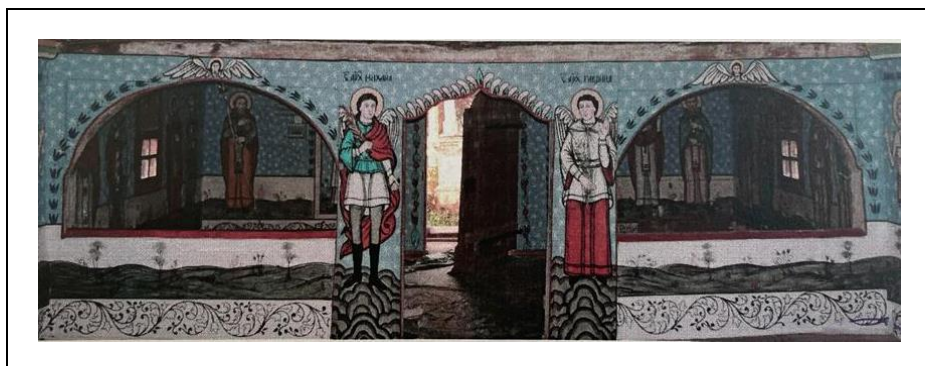
Figure 3. Detail – border in accolade

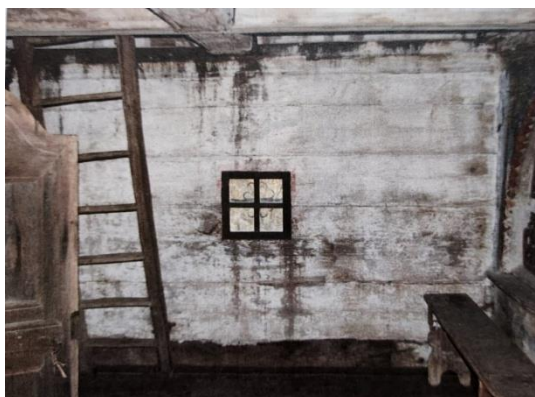
Figure 7. Northern wall assembly - pronaos-before cleaning.

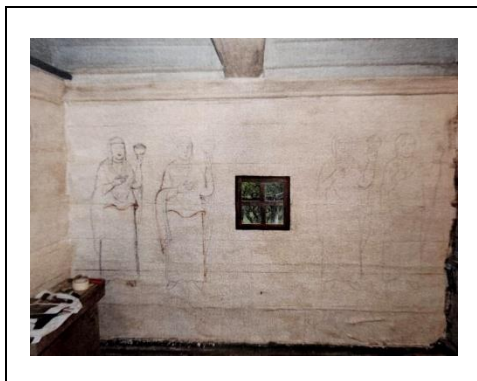
Figure 8. Northern wall assembly – pronaos- after applying the preparation and the drawing.

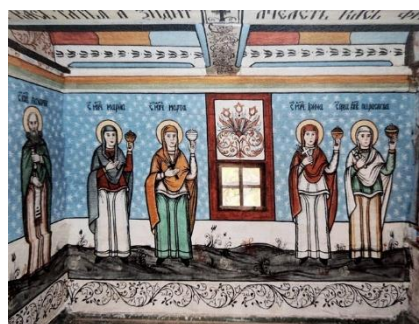
Figure 9. Northern wall assembly - pronaos - after ending the painting: St. Mary, St. Martha, St. Irina and St. Paraskeva
