THE CASTLE OF MICLĂUȘENI
A SPACE OF FAITH, ART AND SCIENCE
ASPECTS OF PRESERVATION-RESTORATION OF
THE INDOOR PAINTING

Abstract

The paper makes a general presentation of the restoration works performed at the Miclăușeni Castle in Romania. The preservation-restoration activity is described from the perspective of the relation religion-art-science. The European tradition and cultural heritage of the former owners of the Miclăușeni domain is also analysed.

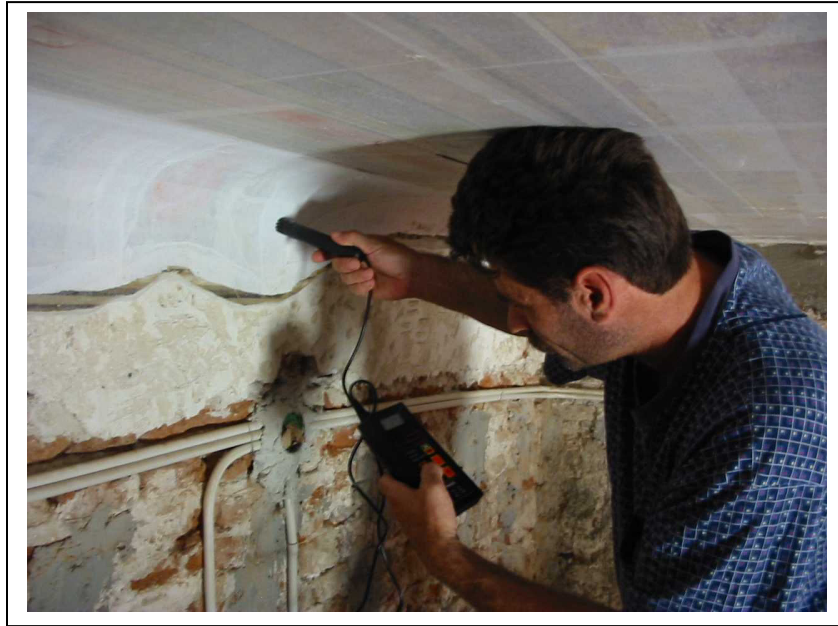
Figure 1. The monitoring of humidity and temperature.

That great humidity remained in the stratigraphy of the ceilings and infiltrated in the wooden, mortar and reed structure leading in time to multiple specific damages that can be also noticed nowadays (Figure 1).

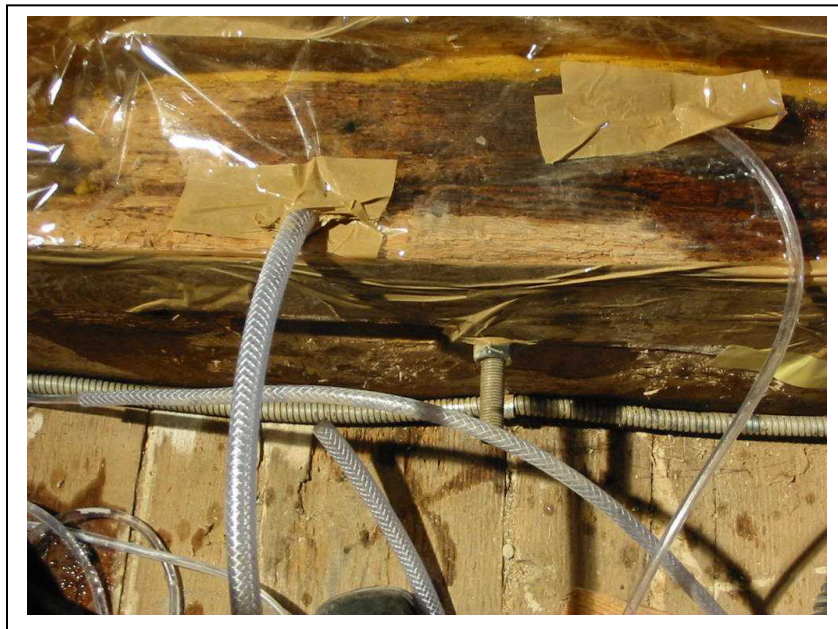
Figure 2. Vacuum consolidation of wooden prop (girders).

The floors whose strength structure was made up of massive wooden beams underwent complex damages mainly due to the presence of the accentuated humidity in several areas (Figure 2). Those damages of the support also lead to the loss of important decorated portions. In order to rescue those decorations that were important so as to illustrate the influence of the “art-nouveau” current within the Romanian art, complex restoration procedures were performed, applied both on the support and the pictorial layer (Figures 3 and 4). The damages of the painted surfaces were stopped by fixing – strengthening the pulverulent areas, as well as the other types of detachments of the colour film.

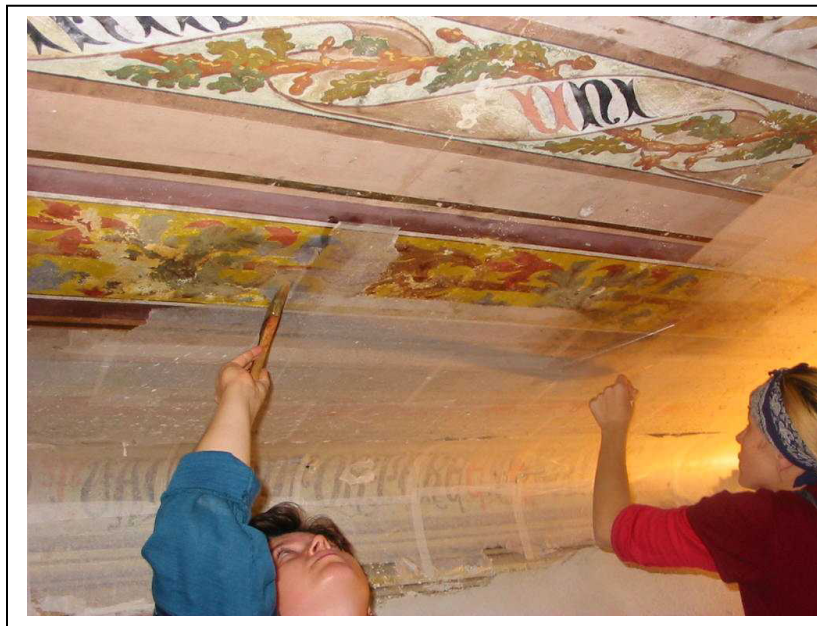
Figure 4. Consolidation of coloured layers.

Applying differentiated treatments, adapted to each type of degradation, it was remade in the first stage of restorations the adherence between the support layer, the preparation and the colour layers, activities which were considered emergencies [3].

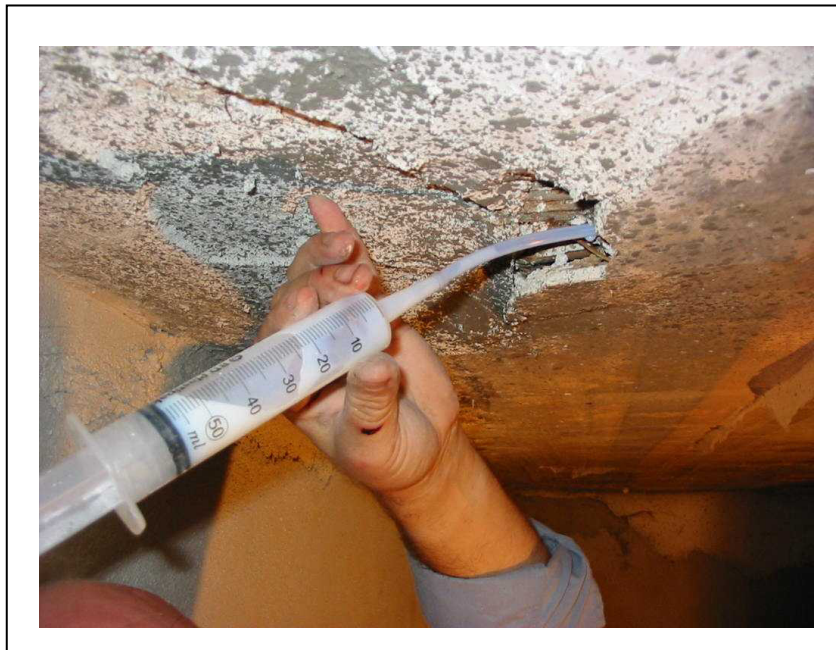
Figure 5. Consolidation of prop detachment (intonaco).

The fractured, detached and deformed areas of the ceilings were horizontally lifted with special devices and laser levels and then different resins were injected so as to strengthen and fix in the plane the respective areas (Figures 5 and 6).
