THE CHURCH 'SAINT NICHOLAS' FROM POPĂUȚI

RESTORATION ASPECTS OF THE MURAL DECORATION

Abstract

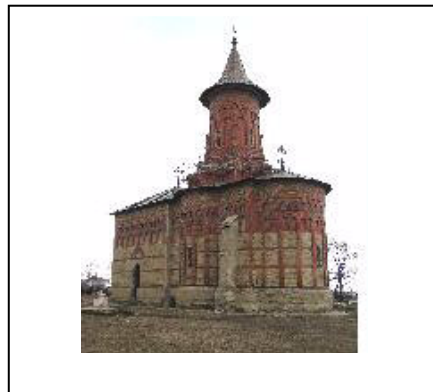
Figure 1. Outside view from south–east.

The church 'Saint Nicholas' has the characteristics of the medieval Moldavian style concerning the project, the interior space, the system of architectural construction and the decorative concept [2] (Figure 1). The interior walls (narthex, nave and altar) were totally covered with mural decorations (Figure 2).

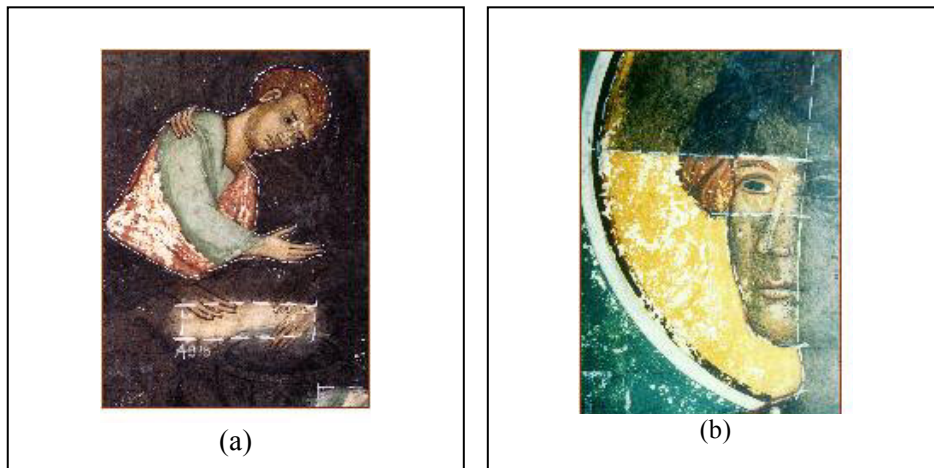
Figure 2. Cleaning tests of the mural paintings: (a) altar; (b) nave, south wall.

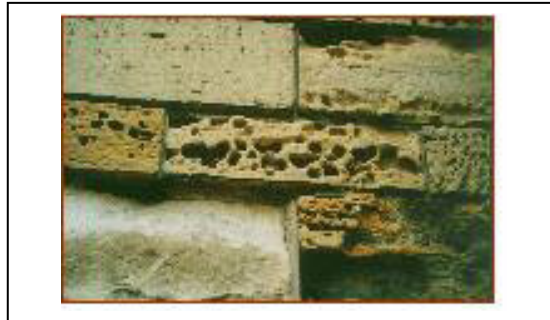
Figure 5. Details with stone and cement plating from the 1906-1908 restoration (the south facade). Humidity effects.

In 1908 the restorations of church was ended by the architect Constantin Băicoianu, radically changing the aspect of the monument by plating the original masonry into a new parament with strict geometrical forms [5].

Concurrently, the level of the inside and exterior pavement was artificially raised with 30–50 cm. This radical action on the architecture produced the modification of humidity parameters. So the degradations were aggressive on the masonry and the paintings (Figure 5). Another intervention that contributed to the change of mural decoration aspect was made between 1926-1927, by diverse works under the coordination of Commission of Historical Monuments [6, 7].
