17TH AND 18TH CENTURY DISTEMPER DECORATIVE PAINT IN WOODEN CHURCHES IN NORWAY PAINTING TECHNIQUE, MATERIALS AND ALTERATION

Tone Marie Olstad* and Anne Apalnes Ørnhøi

Norwegian Institute for Cultural Heritage Research, Storgata 2, N-0105 Oslo, Norway

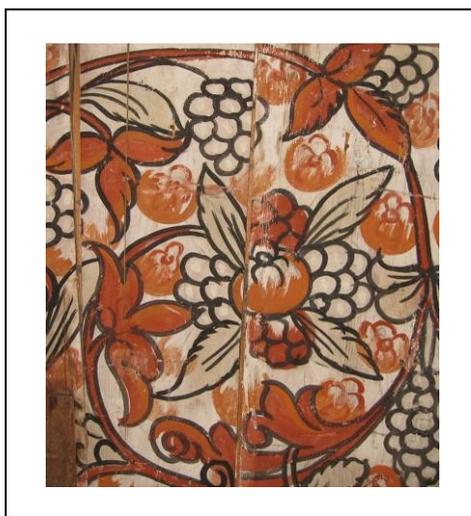
Figure 1. Detail of the distemper painting in Urnes stave church. The painting is dated 1601. Red colours dominate the painting today, but a trained eye observes green, pale violet and yellow. No analyses are done, but the faded colours are most probably dyes.

The distemper paintings in the churches have in general been more colourful than what they are today. This means that one need to be sceptical if the number of colours in decorative distemper paint appears to be limited (Figure 1).

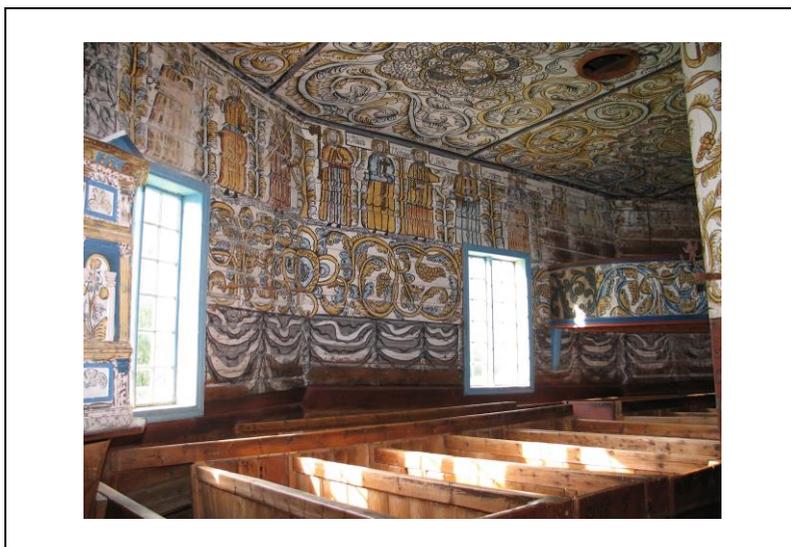
Figure 3. Old Stordal church, Norway. The south wall in the nave. Decorative elements in the upper frieze which seems to be white, have remnants of a blue colour, for example the stems and leaves of the threes dividing the figures. The blue colour in the central frieze is analysed to be Prussian blue. Foto: Birger Lindstad©.

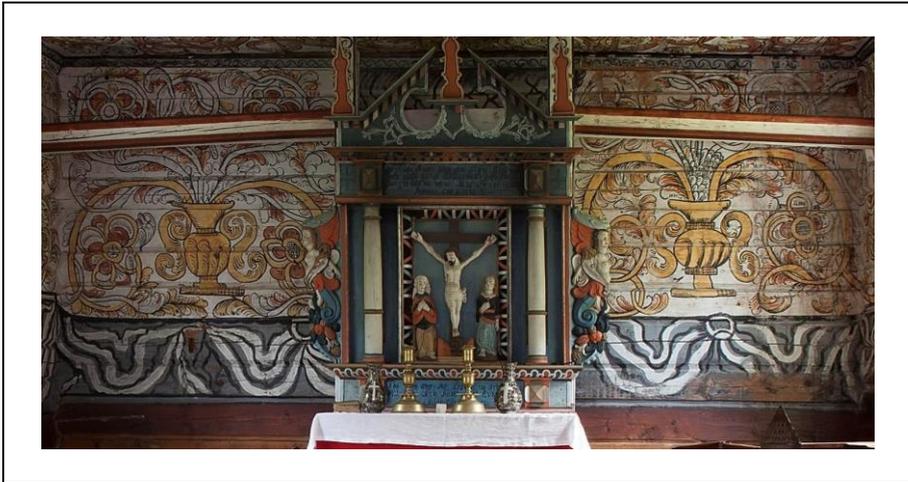
Figure 4. Old Stordal church, Norway. The east wall in the chancel. Foto: Birger Lindstad©.

The distemper paintings in the nave are dominated by blue. Two different blue colours were observed in the paintings in the nave: a well preserved blue colour on the lower part of the wall and a very faded, almost gone, blue higher up. The paintings on the wall in the chancel, however, seemed to lack the blue colour and the dominating colour in the decorative frieze in the upper half of the walls are yellow (Figure 4). Elements which were expected to be coloured, like the coiling foliage, appear white.

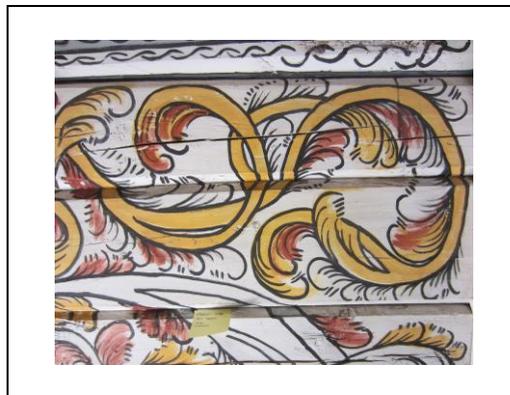
Figure 5. Old Stordal church, Norway. Detail from the south wall in the chancel. The yellow post-it note shows where the blue colour was observed and where the sample was taken. Photo: Tone Olstad©.

However, during the conservation work with the wall paintings in the chancel, remains of a blue colour were found in areas protected from light, for example between the logs (Figures 5-7). Because of the degree of deterioration, this blue is assumed to be a dye. As seen in the Table 1 a few blue dyes were in use in this period. As indigo was the most widely used blue for distemper paint

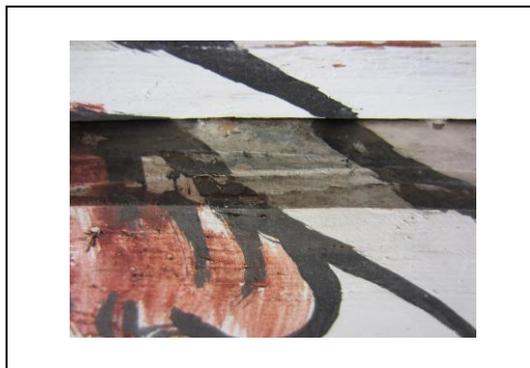
Figure 6. Old Stordal church, Norway. Old Stordal Church, Norway. Detail from the south wall in the chancel showing the traces of the blue colour. Photo: Tone Olstad©.

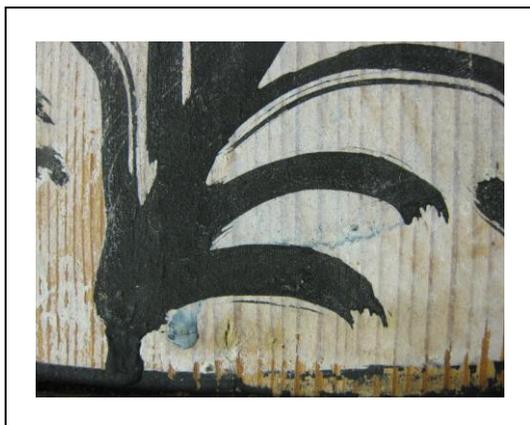
Figure 7. Old Stordal church, Norway. Detail form the chancel. The blue colour has been painted almost like a glaze and in the collected drip the colour is still blue. Photo: Tone Olstad©.

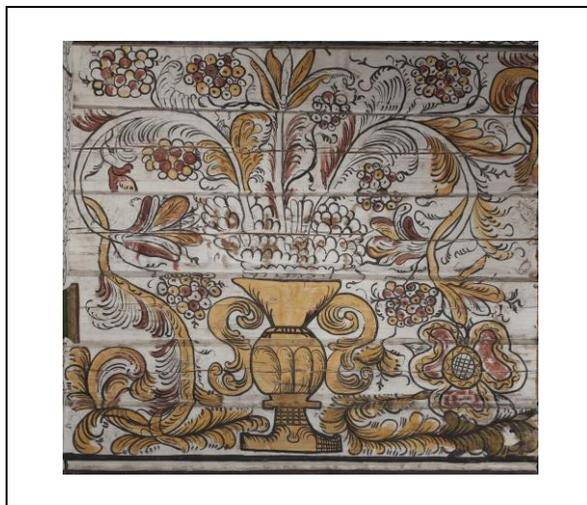
Figure 8. Old Stordal church, Norway. Detail from the paintings in the chancel. The yellow and reds are preserved - other colours are faded. Traces of a blue are seen where the paint has been more protected from light. Photo: Tone Olstad©.

More research is needed to establish if green was the original colour of the blue areas in the nave as well as the white tendrils in the chancel of Old Stordal church (Figure 8). If this was indeed the case, the total original impression of the church interior was probably quite different from the present day appearance. Based on the visual examinations and analysis, a digital representation has been made to give an impression of how the decorations might have appeared in their original state (Figures 9 and 10).

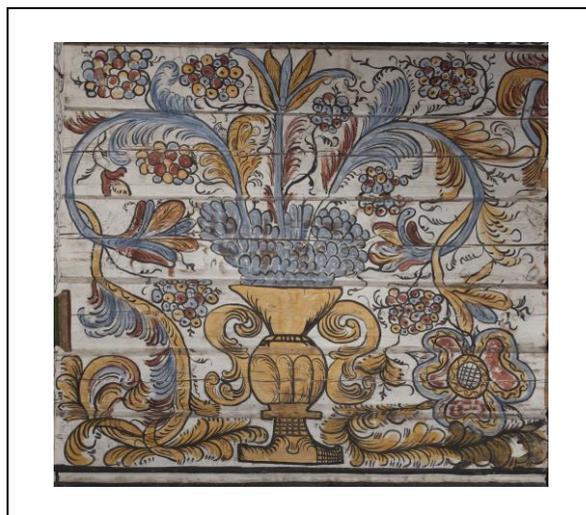
Figure 9. Old Stordal church, Norway. The same detail as in Figure 8 with a blue colour digitally filled in. The blue colour is an interpretation of the found colour done by the conservators. Photo: Tone Olstad©.

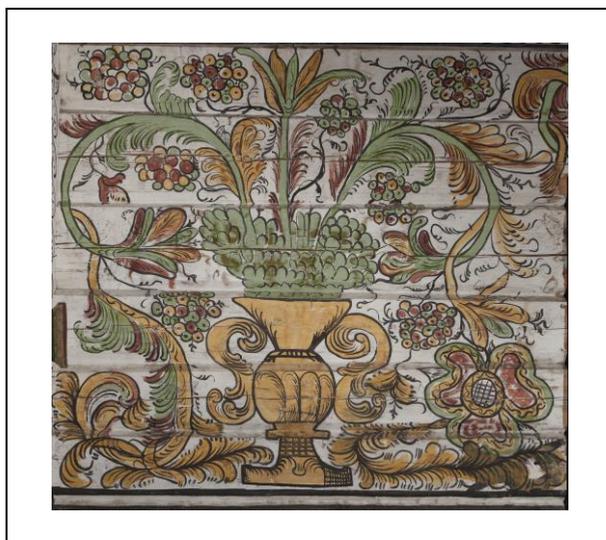
Figure 10. Old Stordal church, Norway. The same detail as in Figure 8 with a green colour digitally filled in. The green colour is an interpretation done by the conservators. The residues of blue might have been a green colour made from a fugitive yellow and an unstable blue. Photo: Tone Olstad©.
